Manhole Inspection Summary

Manhole # S35Y__010MH

Insp Date: **3/26/08 9:43 AM**

Location Address: **1910 light rear**

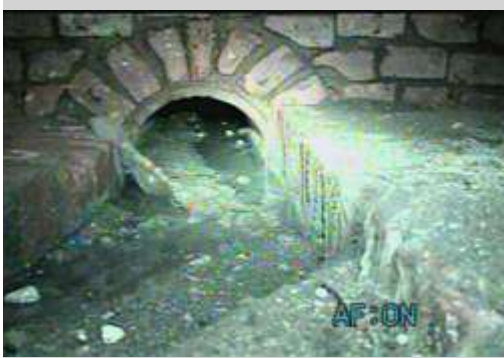
Defect 4

Condition: ☐ Sound ☐ Cracked ☐ Root Intrusion ☐ Deteriorated ☐ Leaks ☒ **Debris**

channel debris

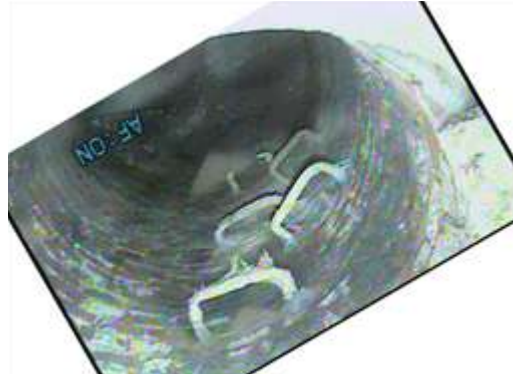
Defect 3

Steps Count: **5** Missing: **1** ☒ **Corroded**

missing/corroded steps

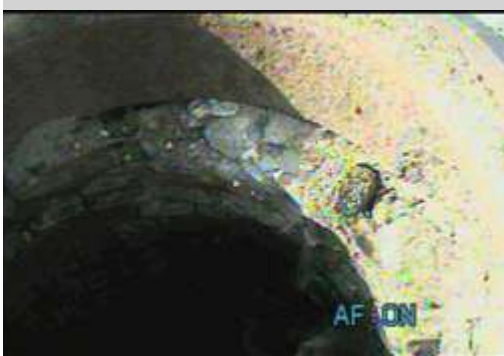
Defect 1

Frame Offset: **4** (in.) Condition: ☒ Sound ☐ Cracked ☐ Leaks

off set frame

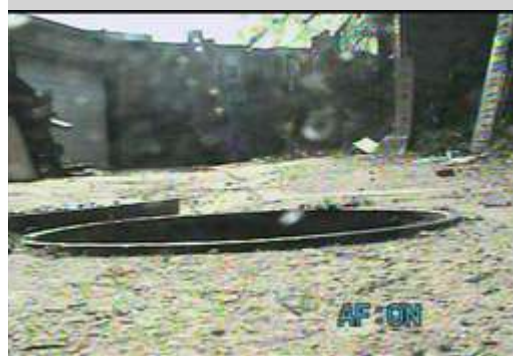
Defect 2

Cover Shape: **Circular** Diameter: **24** (in.) Length: **0** (in.) Dist A/B Grade: **1** (in.)

cover above pavement

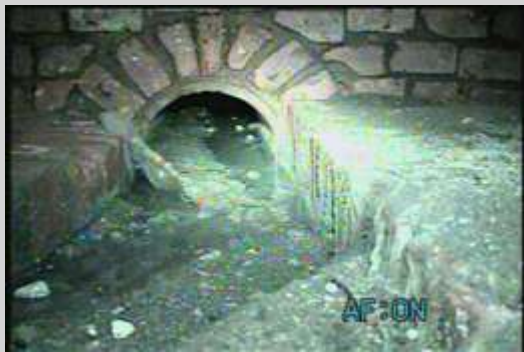
12 O'Clock Outflow

8 in. Circular Gravity Sewer
Pipe Out @ 12 O'Clock

Infiltration: **None** Pipe Seal Cond: **Unknown**

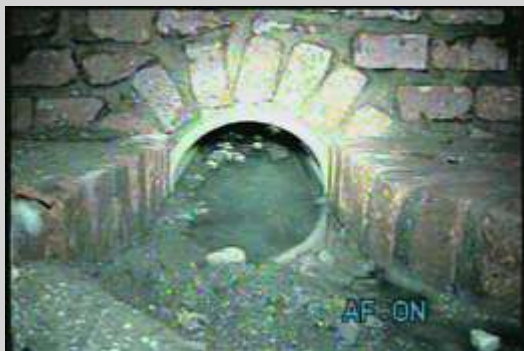
8 O'Clock Inflow

8 in. Circular Gravity Sewer
Pipe In @ 8 O'Clock

Invert Depth: **9.80** (ft.) Flow Characteristics: **Slow**

Infiltration: **None** Pipe Seal Cond: **Unknown**
